### SURVEYOR INTERCEPTOR PRECISION AT SPEED

### SURVEYOR INTERCEPTOR (SROV)

## FULL SCALE SROV TRIALS

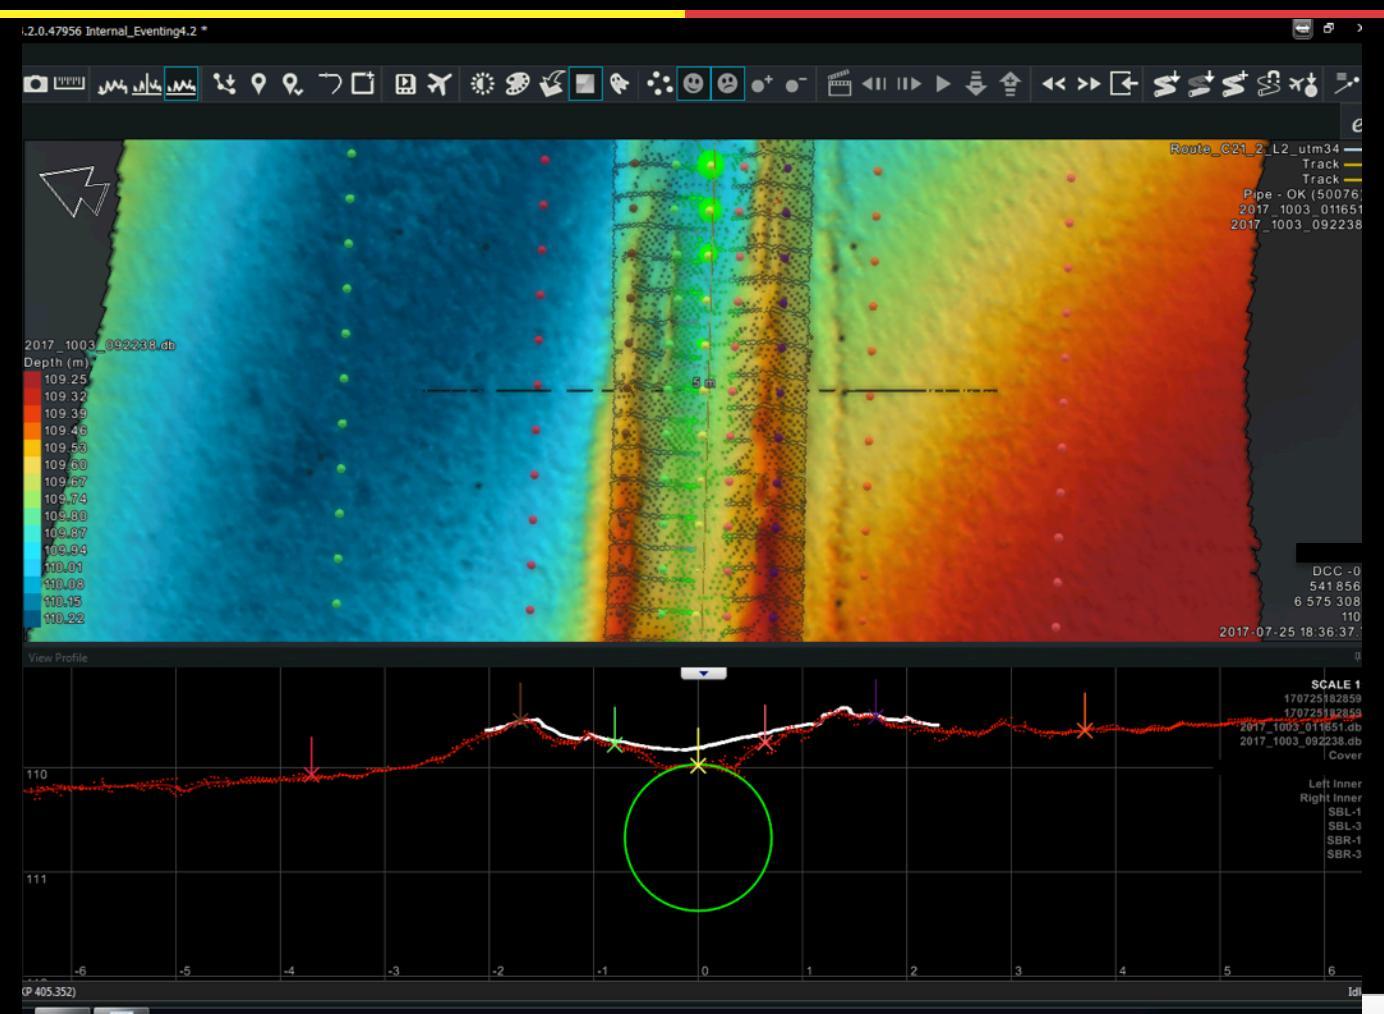
### PENETRATION AND INNER FLAGS

MBES clearly penetrates (RED line) – inner flags incorrect Laser and photogrammetry no penetration

- Laser (and photogrammetry) can be of great value for the Top Of Pipe (TOP) and inner flag quality in areas with penetration issues, however subject to visibility
- MMT plans to conduct a test during Q4 to use two high frequency MBES to cover the TOP ±1.5 m with the purpose to increase the quality of the data and not be dependent on visibility

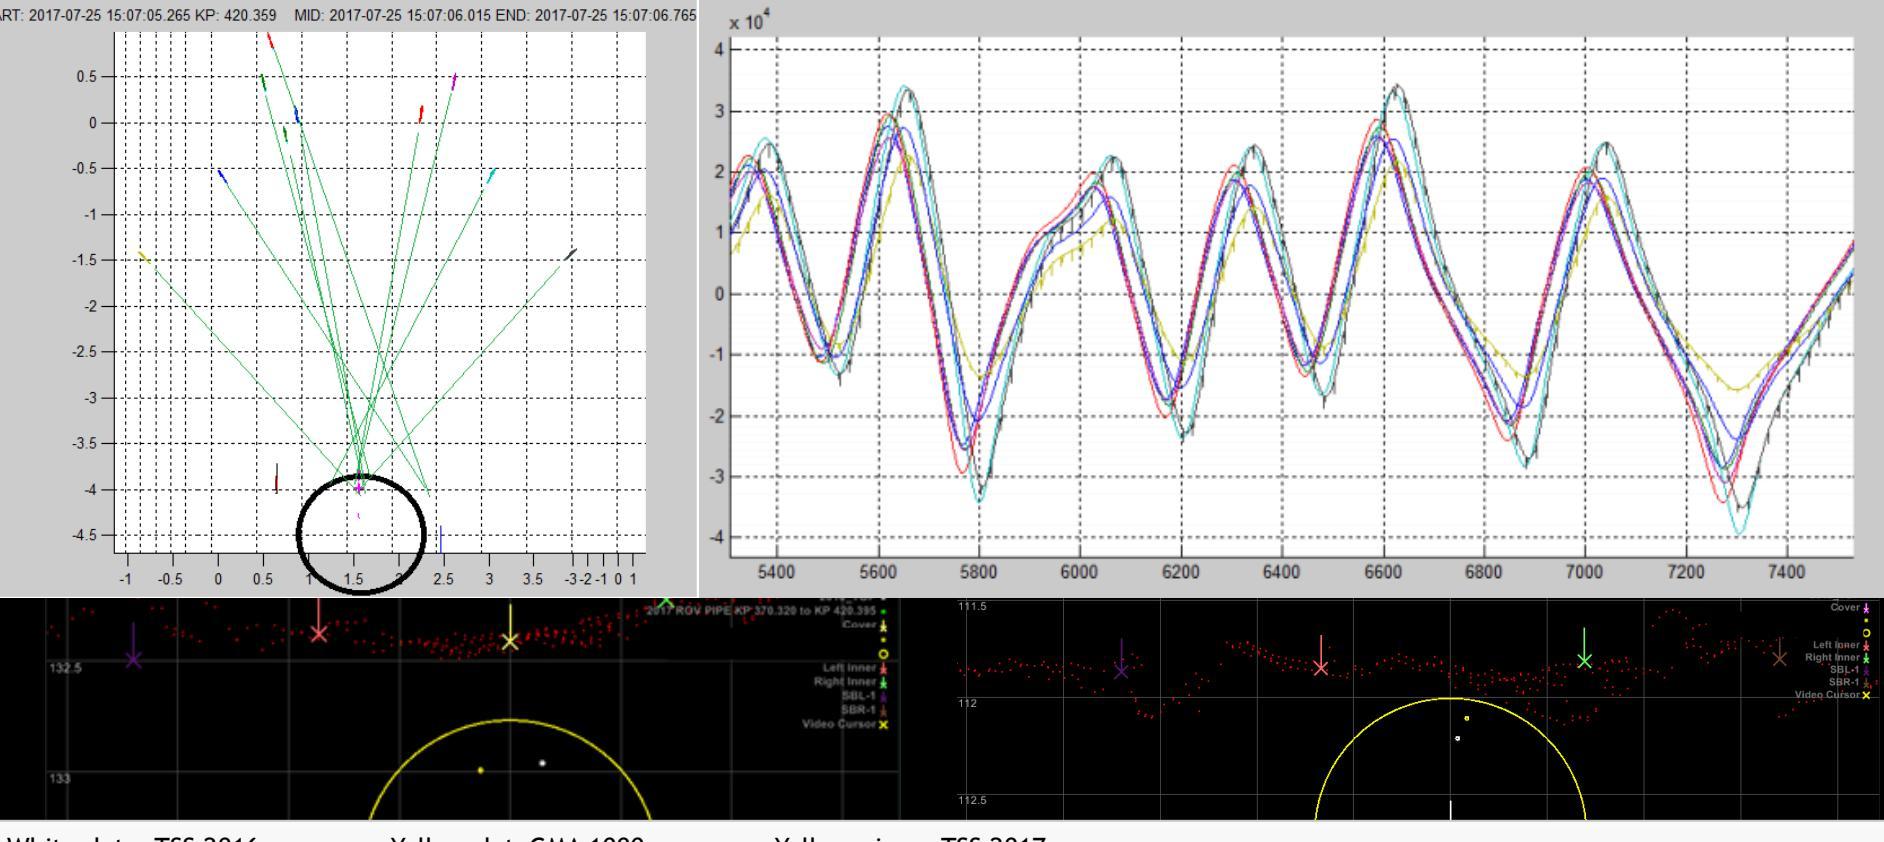
## **PIPETRACKER / DOB**

White dot = TSS 2016 Yellow dot=GMA 1000 Yellow pipe = TSS 2017 A passive pipe tracking system has been developed on 10 GMA-1000 sensors in the SROV and the boom arms.

The results show that pipe detection with a <0.2m accuracy is possible. The position of the boom arms is crucial and a system to utilise precise angle sensors is presently being developed. More test runs are necessary.

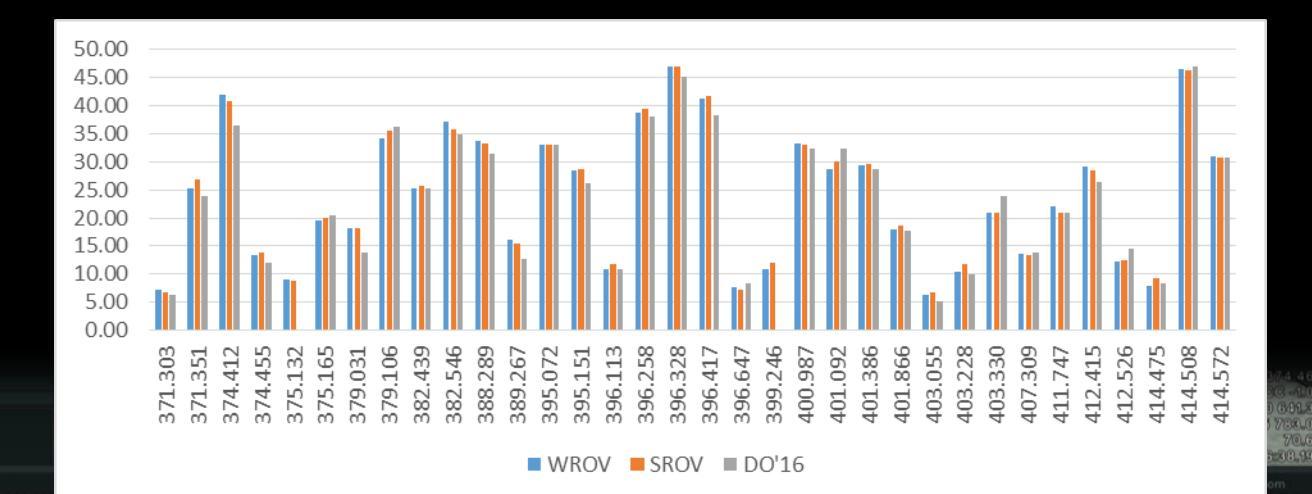
### FREESPANS (B209F)

There is one new freespan reported 2017 compared to 2016. The WROV and the SROV survey correlates well.

The surveys were conducted only 10 days apart, the variances in total length is likely due to the different survey configuration and subjective processing. There is a trend towards longer freespans from 2016-2017.

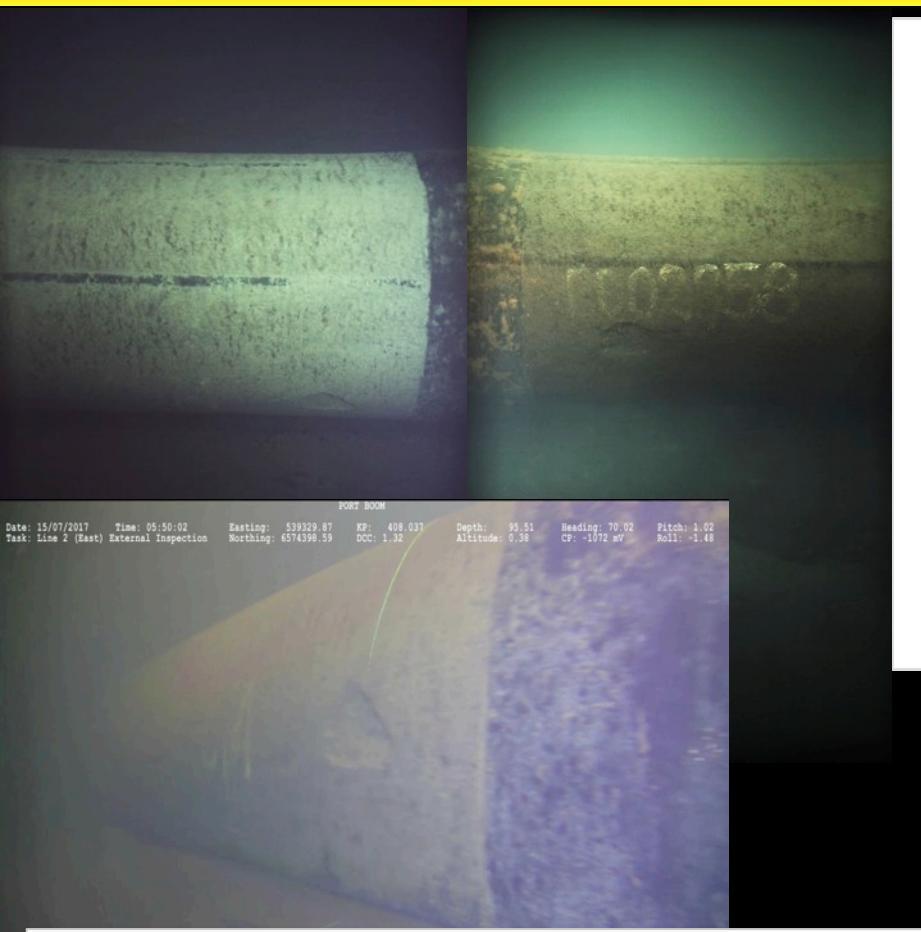
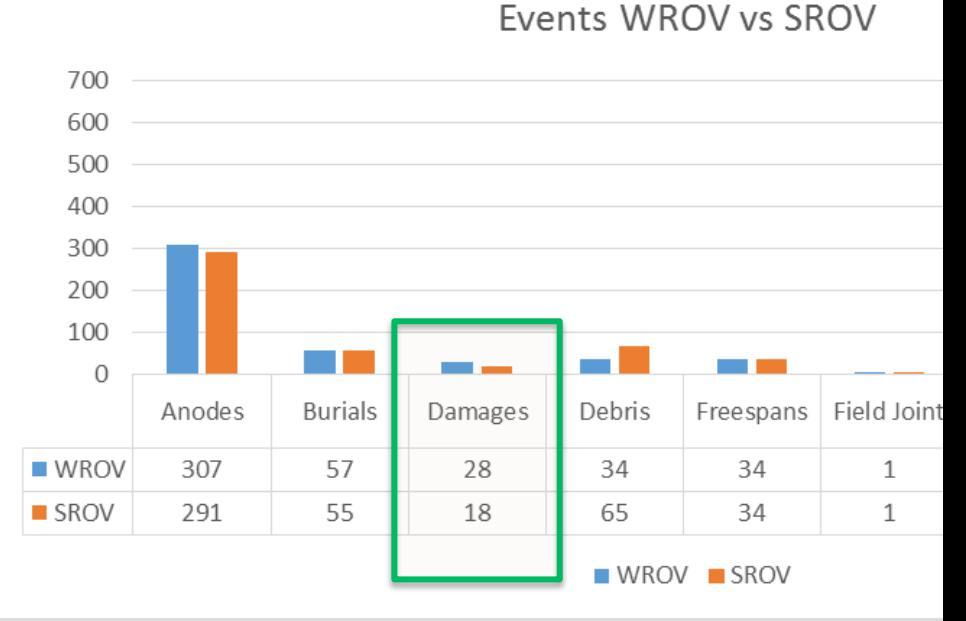
### DAMAGES (B209F)

The 2017 SROV survey struggled to identify damages at clock position 4 to 8 – lower survey altitude needed

The 2017 WROV survey reported 16 damages outside clock position 5 to 7 compared to the SROV's 18

• Survey altitude needs to be lower and additional lights to be fitted to the booms for visual confirmation
