### SURVEYOR INTERCEPTOR PRECISION AT SPEED

### SURVEYOR INTERCEPTOR (SROV)

## FULL SCALE SROV TRIALS

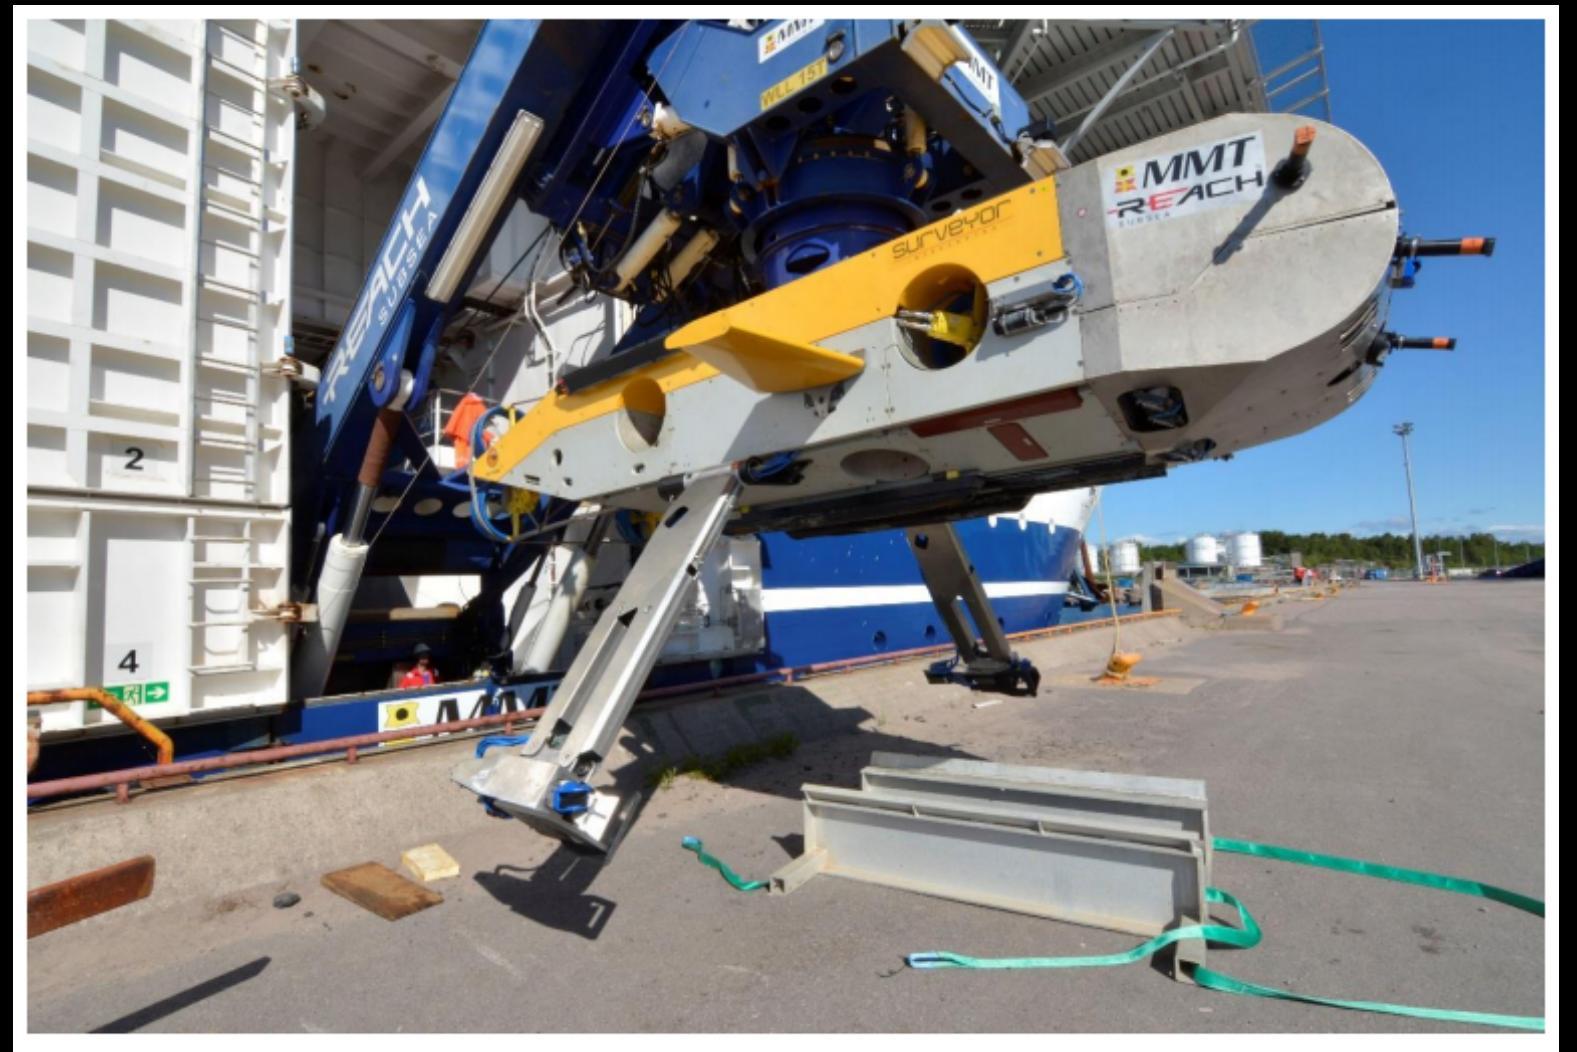
Figure 3 Newly added boom arms with cameras, gradiometers, imaging sonars.

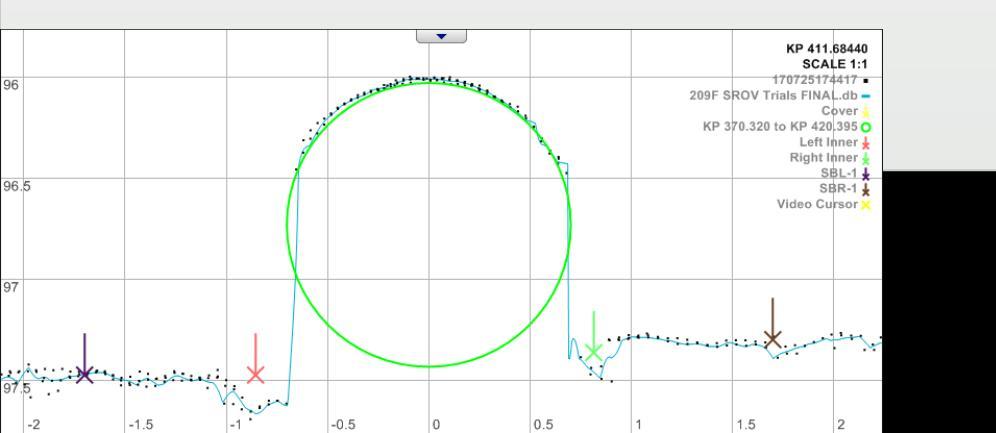
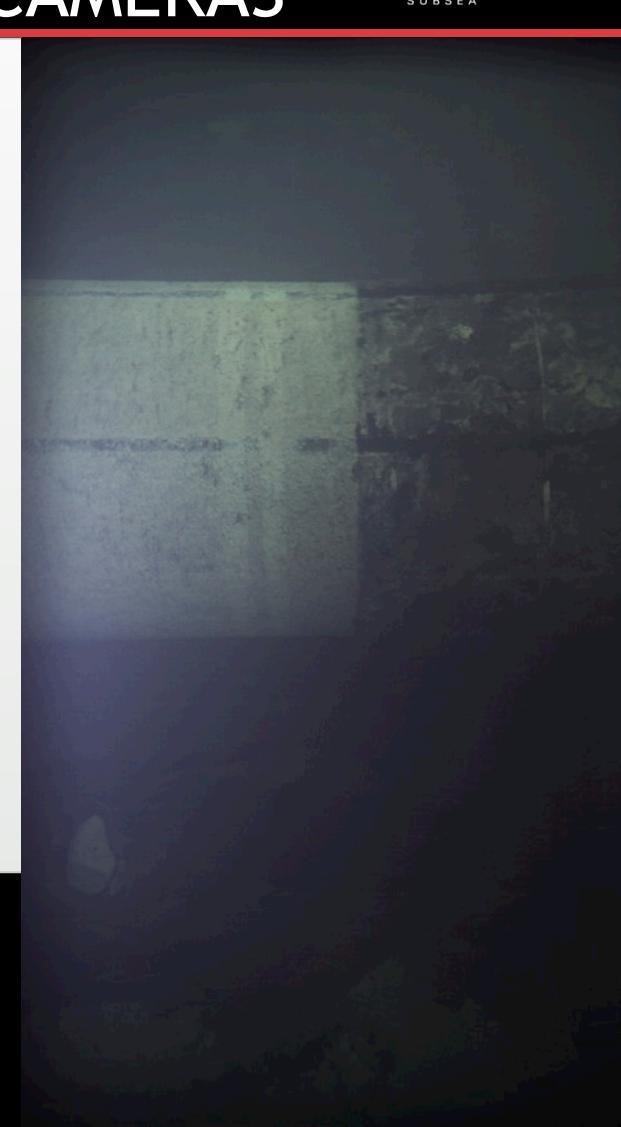
- Freespan detection using acoustic sensors correlates with previous surveys
- Minor freespans are sensitive to degraded MBES data (see example below)

Lower events hard to distinguish at dark seafloor

• Survey altitude needs to be lower and additional lights to be fitted to the booms for visual confirmation
