Emergency Pipeline Repair Systems (EPRS)

An overview of the tools and methods available for the
on-bottom repair of rigid pipelines

SUT-ME EPRS Mechanical Solutions

Presented by: Oceaneering International

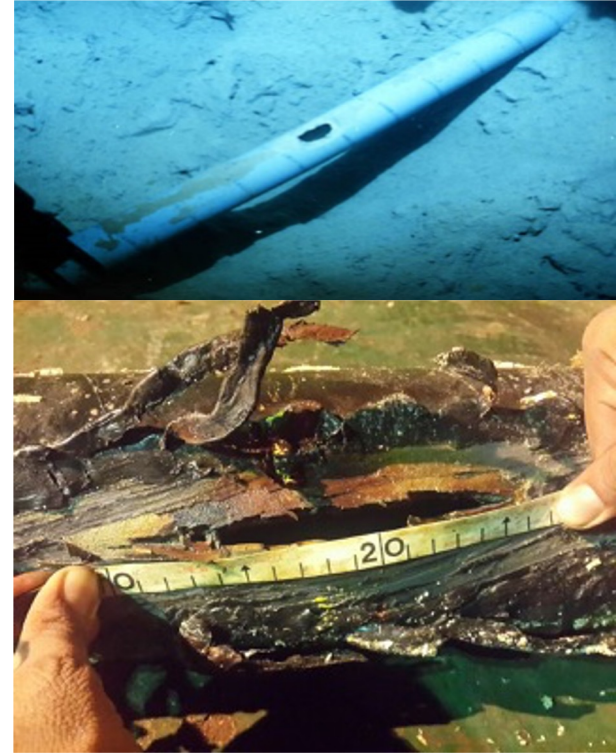
- **Repair Methods:** Mechanical, Welded, Wrapped
- **Local Repair (Mechanical):**
Repair Clamp installed on a localized damaged section of the pipe (e.g. pin hole , corrosion, dent, etc.)
- **Major Repair (Mechanical):**
Section of the pipe is cut away and replaced with a spool piece & repair connectors on both sides
- **Shallow Water Repair:**
Up to 300m/1,000 ft – Diver Executed
- **Deep Water Repair:**
Beyond 300m/1,000 ft – ROV Executed

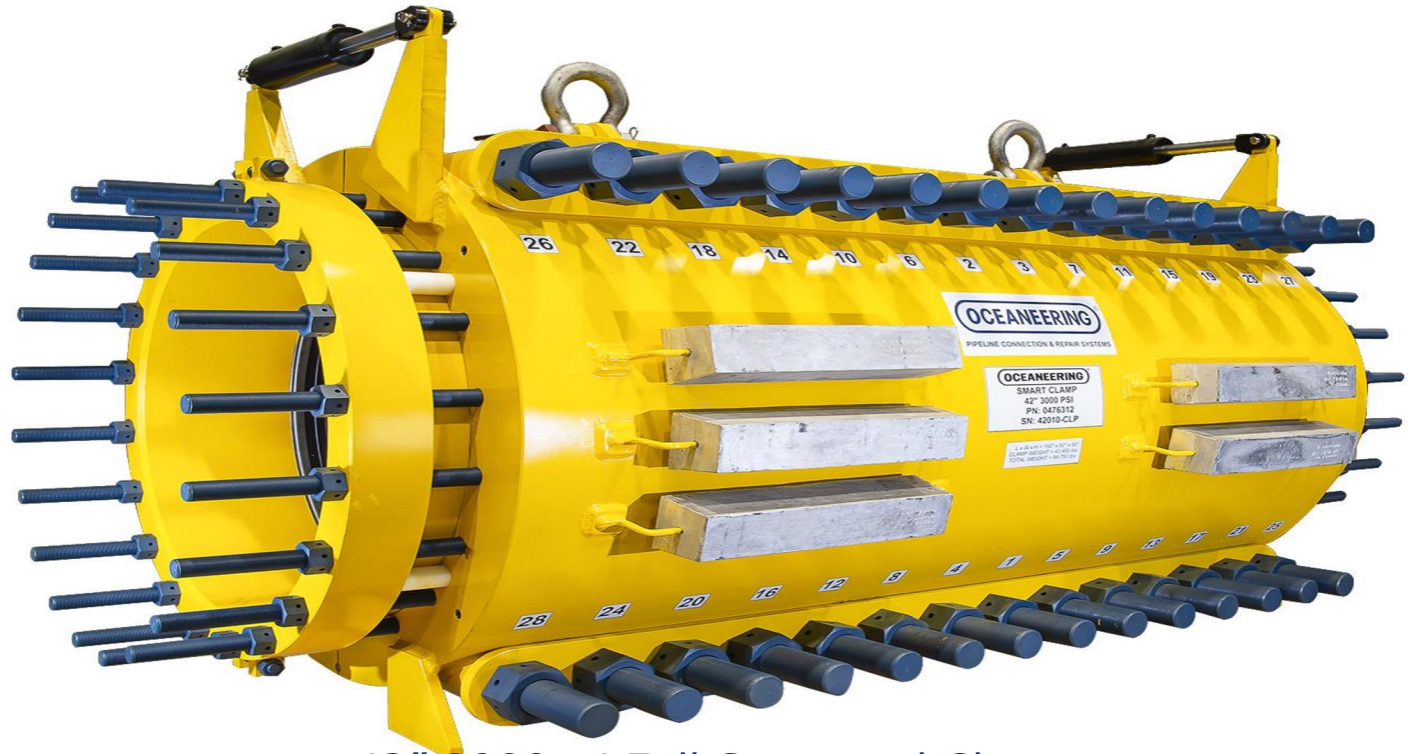
Structural Repair Clamp (local repairs)

42" 3000psi Full Structural Clamp

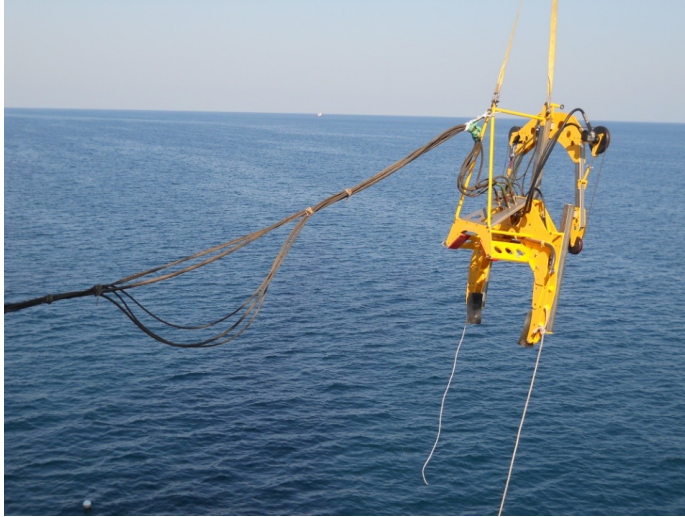
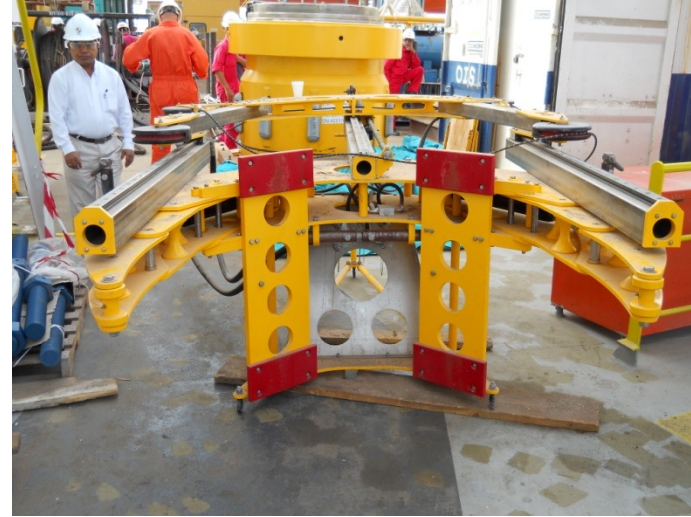
42" MAIN OIL LINE: SUBSEA ON-BOTTOM SPOOL PIECE REPAIR USING SMART FLANGE PLUS CONNECTORS

PIPE CUTTING TOOL (DIAMOND WIRE CUTTER)
BEING PREPARED FOR SUBSEA DEPLOYMENT

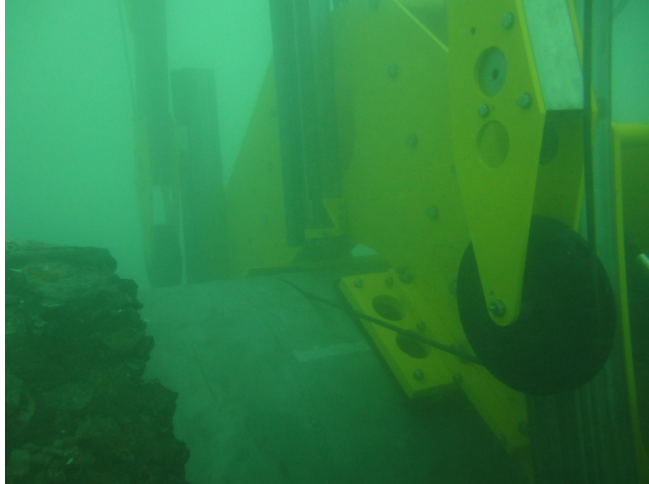
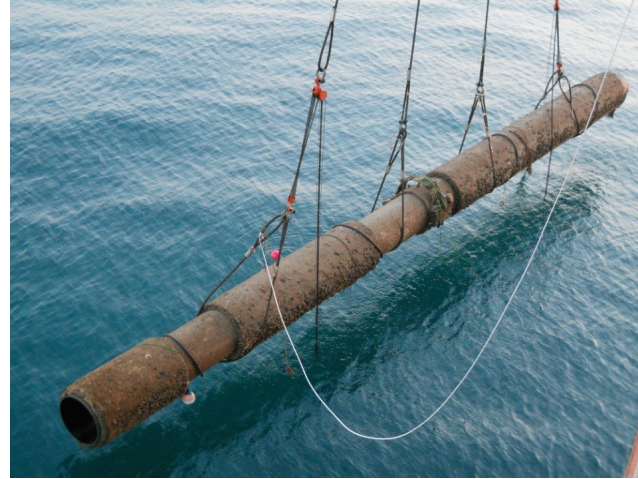
42" MAIN OIL LINE: SUBSEA ON-BOTTOM SPOOL PIECE REPAIR USING SMART FLANGE PLUS CONNECTORS

CUTTING & REMOVAL OF DAMAGED SECTION OF 42"
SUBSEA PIPELINE

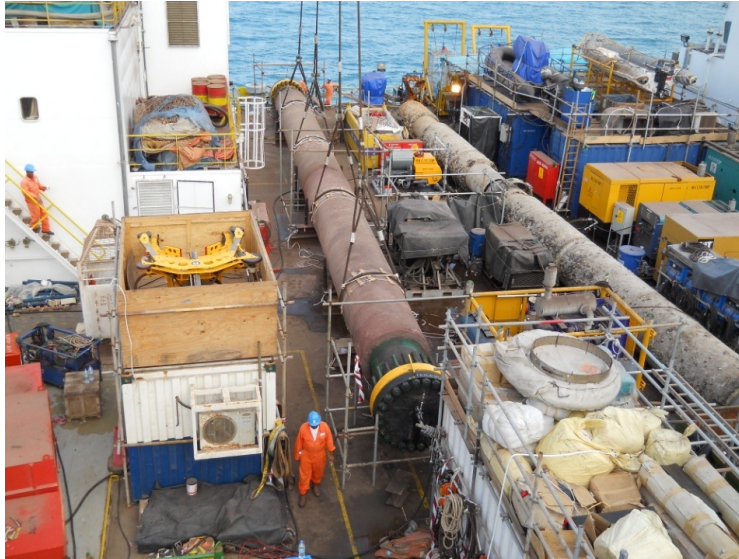
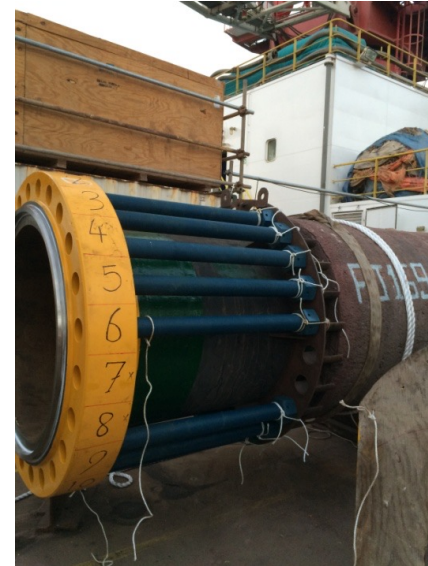
42" MAIN OIL LINE: SUBSEA ON-BOTTOM SPOOL PIECE REPAIR USING SMART FLANGE PLUS CONNECTORS

SPOOL PIECE REPAIR FABRICATION

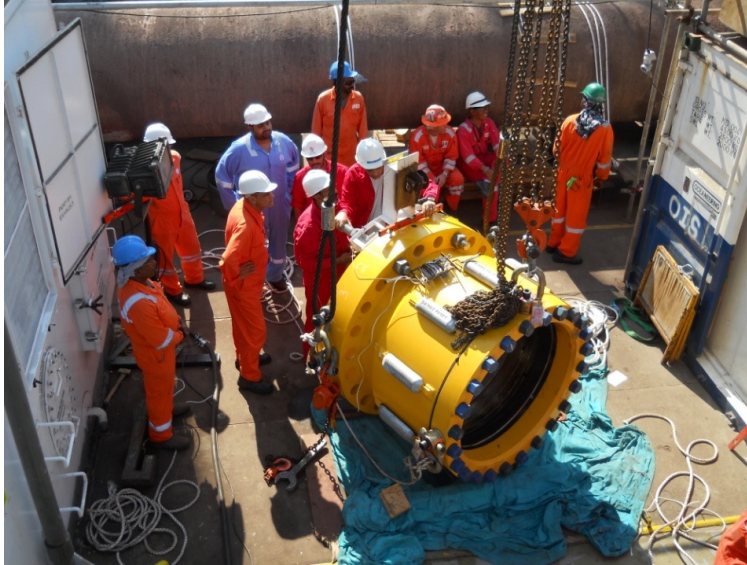
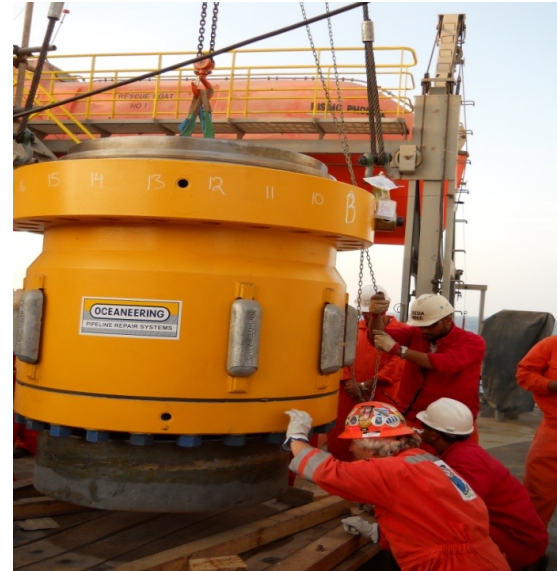
42" MAIN OIL LINE: SUBSEA ON-BOTTOM SPOOL PIECE REPAIR USING SMART FLANGE PLUS CONNECTORS

CONNECTORS BEING PREPARED FOR SUBSEA DEPLOYMENT

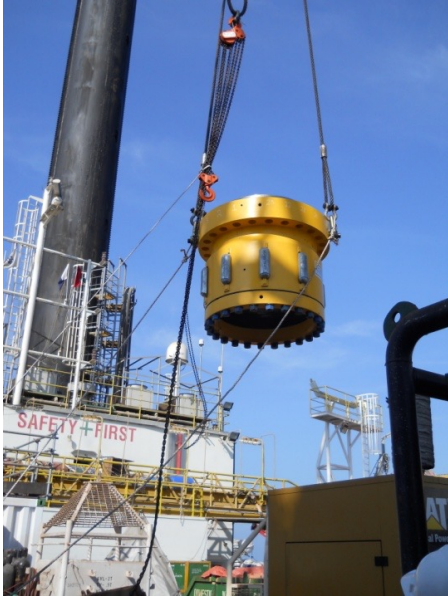
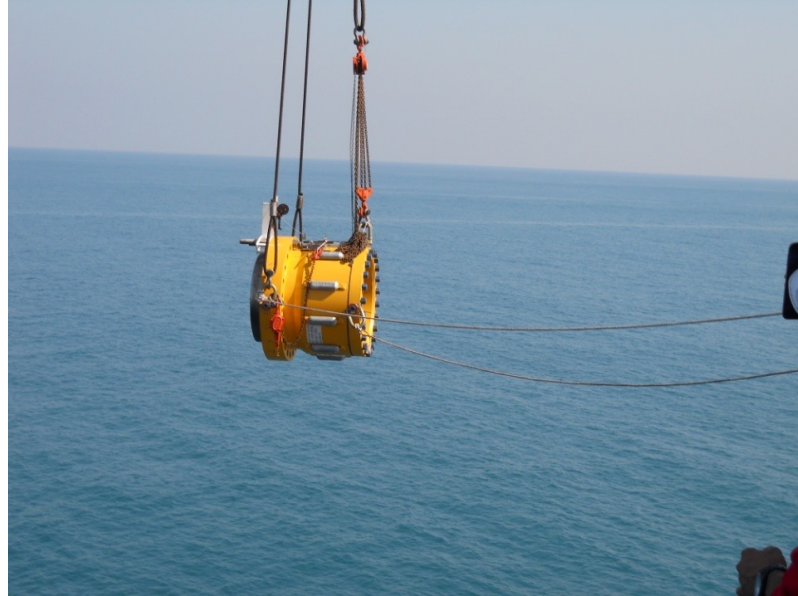
42" MAIN OIL LINE: SUBSEA ON-BOTTOM SPOOL PIECE REPAIR USING SMART FLANGE PLUS CONNECTORS

CONNECTORS BEING DEPLOYED SUBSEA

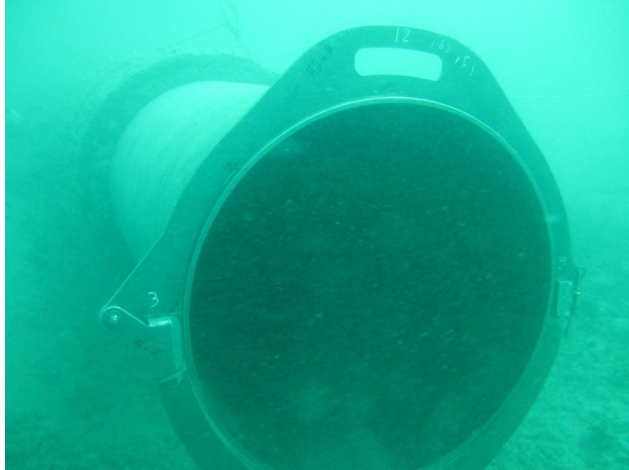
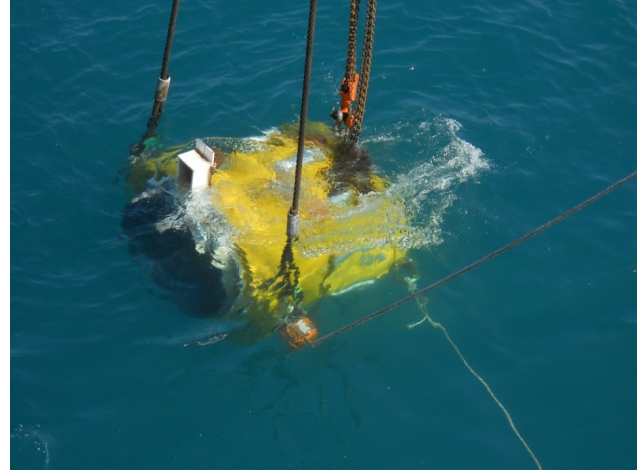
42" MAIN OIL LINE: SUBSEA ON-BOTTOM SPOOL PIECE REPAIR USING SMART FLANGE PLUS CONNECTORS

PIPE IS CHECKED FOR OVALITY USING A PIPE SIZING RING & CONNECTORS ARE DEPLOYED SUBSEA

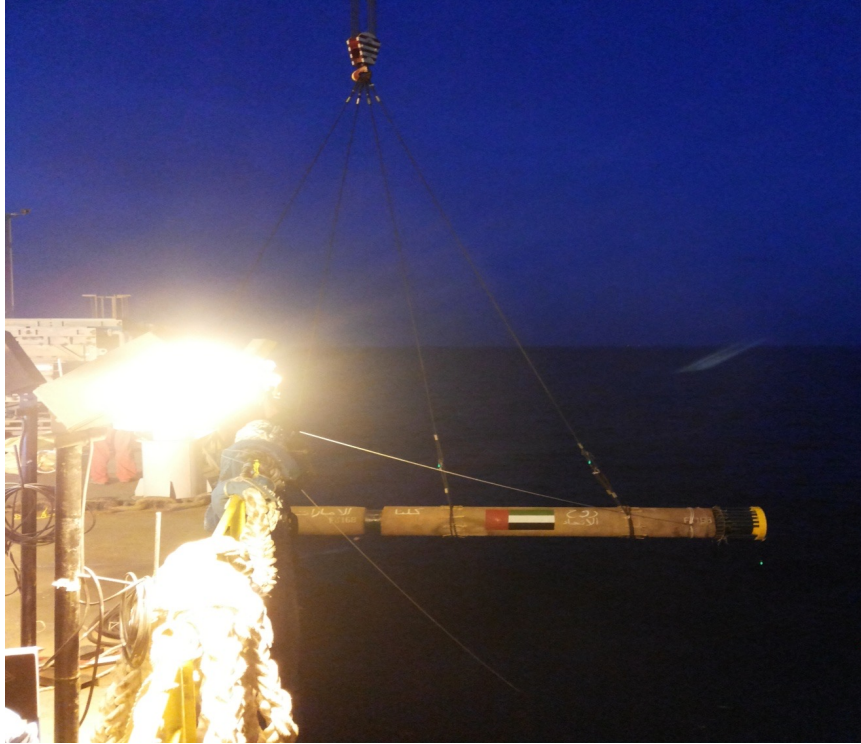
42" MAIN OIL LINE: SUBSEA ON-BOTTOM SPOOL PIECE REPAIR USING SMART FLANGE PLUS CONNECTORS

NEW FABRICATED
SPOOL PIECE IS
BEING DEPLOYED
SUBSEA

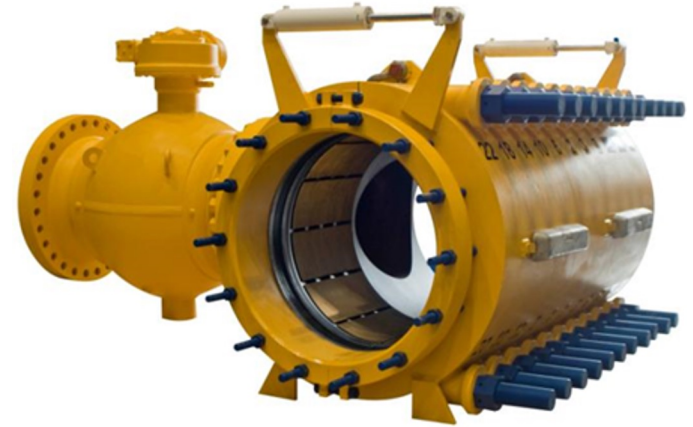
Structural Smart Tap

- No need to shutdown the pipe
- Installable in both horizontal or vertical plane
- Structurally reinforced connection allows larger diameter taps
- Bundle service package include Technicians and Equipment
- Stocked as clamp bodies with a quick turnaround time to be machined and add the valve flange in accordance with customer specification
